**Technical Service  
BULLETIN**

**M.I.L. "ON" DTC P0171, P030#, AND/OR  
P0133 ENGINE RUNNING LEAN IN  
SUBFREEZING AMBIENT  
TEMPERATURES**

**'00 – '05 Celica (1ZZ-FE)**

**ENGINE  
EG046-07**

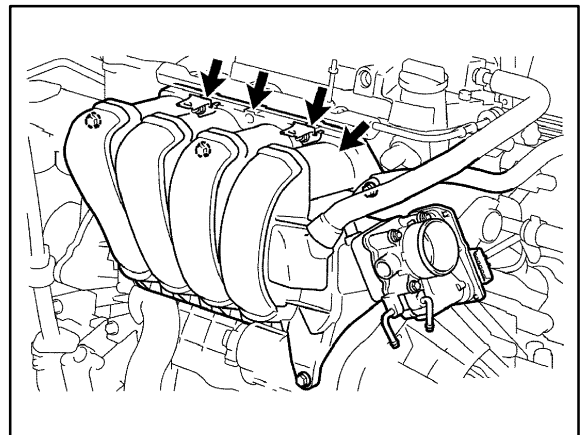
2. Following conventional diagnostic procedure, confirm if there is a leak where the intake manifold and cylinder head meet between each intake runner.

3. Did the short term fuel trim change to a rich reading (negative fuel trim) in step 2?
  - If **YES** — Replace the intake manifold gasket.
  - If **NO** — Check for other vacuum leaks or lean running conditions per the Technical Information System (TIS).
